**Flood Control Project Maintenance
Levee Inspections**

Maintenance Issue Types Only, Levee Inspection Report By Mile - Spring 2018

Yolo County Service Area 6

Waterway	Bank	Unit Miles	Inspection Start/End	Inspector
Unit No. 01 Right Bank of Sacramento River at Knights Landing	Right	5.87	03/15/2018 03/15/2018	Zach Jojola

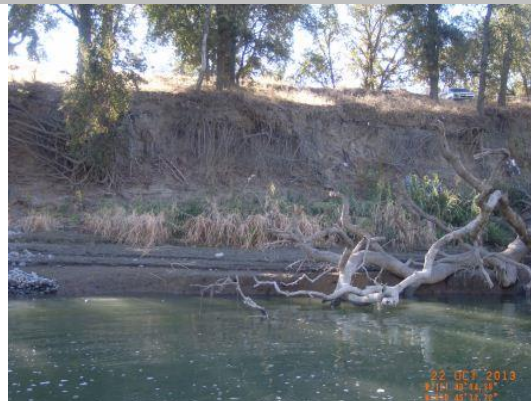
Photo 1 of 3 : SP_2018_NA0022_350_4_20180306_00003.jpg

2006 - Approximately 18 to 20 ft of bank near levee at the corner of the levee and the Freemont Weir. Vertical bank with undercutting/mass failure. 2007 - Staked at top of bank for monitoring. 2011 - Site has become significantly worse with more of the toe and lower bank eroded. Many trees have fallen since last year. 2012 - Site looks worse with more erosion around trees. 2013 - Additional erosion into the toe. 2015: Site extended upstream about 500 ft to account for eroding bank. [2015 Site ID: SAC_83-9_R]

USACE 2013 Photo #1

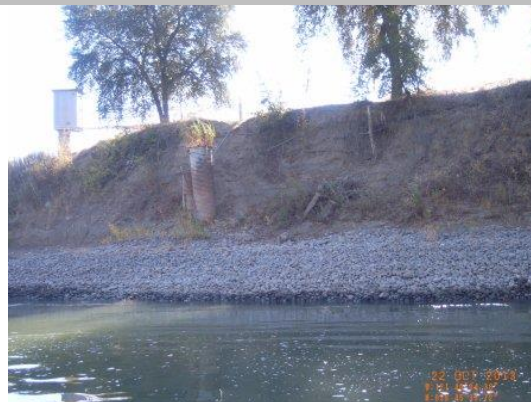
Photo 2 of 3 : SP_2018_NA0022_350_4_20180306_00004.jpg

USACE 2013 Photo #2

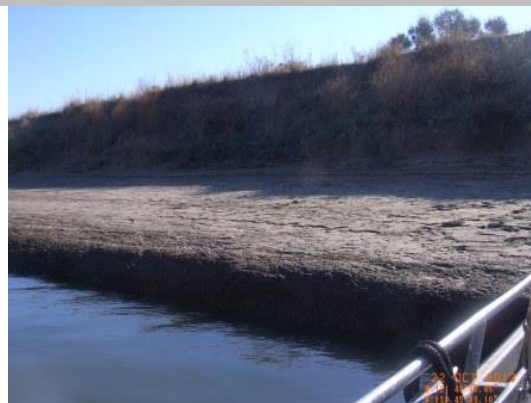
Photo 3 of 3 : SP_2018_NA0022_350_4_20180306_00005.jpg

LM Start	5.67	Rating **	M	Issue No.	4 (cont)	
LM End	5.85	Issue Type +	Ma	Location *	WS	
Category	Supplemental			GPS Latitude/Longitude		
				Start	End	
Item	2015 USACE Erosion Survey, DRAFT			38.759000 °	38.759390 °	
				-121.670759 °	-121.667500 °	
DWR ID	DWR_NA0022_01_s_2017_4					
Comment Code						
Inspector Comment						
2006 - Approximately 18 to 20 ft of bank near levee at the corner of the levee and the Freemont Weir. Vertical bank with undercutting/mass failure. 2007 - Staked at top of bank for monitoring. 2011 - Site has become significantly worse with more of the toe and lower bank eroded. Many trees have fallen since last year. 2012 - Site looks worse with more erosion around trees. 2013 - Additional erosion into the toe. 2015: Site extended upstream about 500 ft to account for eroding bank. [2015 Site ID: SAC_83-9_R]

USACE 2013 Photo #3

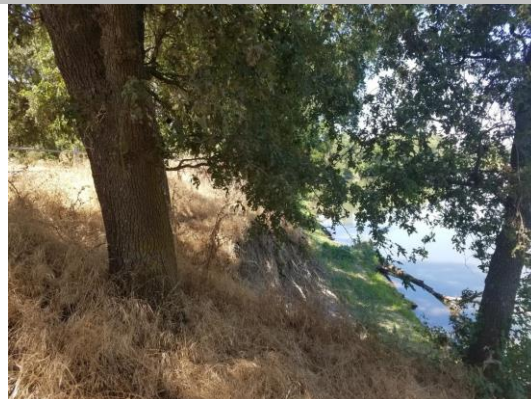
Photo 1 of 1 : LEVAL_SP_2018_490_4925.jpg

LM Start	5.85	Rating **	A/W	Issue No.	57
LM End		Issue Type +	Ma	Location *	
Category	Supplemental			GPS Latitude/Longitude	
				Start	End
Item	2017 Storm Damage			38.759100 °	°
				-121.667964 °	°
DWR ID	DWR_NA0022_01_f_2017_57				
Comment Code					
Inspector Comment					
Levee Evaluation Comments					
Description:Immediately U.S. of Fremont Weir					
Site ID No:490					
Site Designation:LMA-328					
Repair Type: Erosion					
Rating:Serious					
Field Date:7/27/2017					
Notes: wide crown. Erosion not in prism. May be a new erosion pocket, but need to compare to fsrp data. Old veg still present.
